Concrete Waterproofing Manufacturing Pty Ltd
T/A XYPEX AUSTRALIA
ABN 96 093 161 963

**Project Manager
Hansen Yuncken Pty Ltd
25 Huntingdale Road
Burwood, Victoria 3125**

Update - Core samples collected from Monash University Car Park, VIC

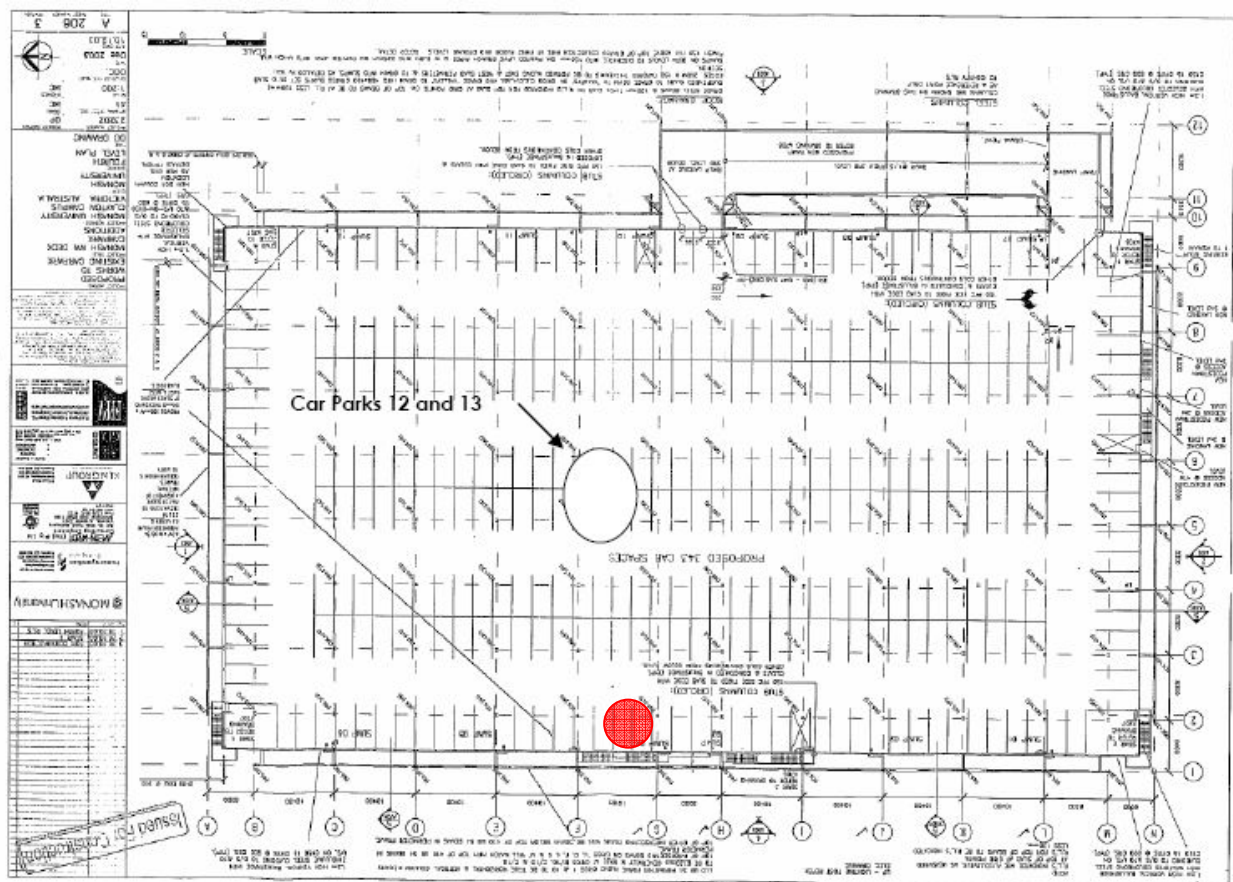
Fig 1. Locations of the core sample

A copy of preliminary report issued by ANCON was provided on 01/02/06 as a reference material (dated 31/01/06). Core samples from the Monash University Car Park were received on 27/01/06 from Xypex Melbourne office. Locations of the core sample were mapped out as shown in red circle in Fig 1 (engineering drawing sourced from the attachment in the ANCON's report). They were labelled as Sample 2, Sample 2A, Sample 4 and Sample 5. Digital photos were taken on all samples prior to any testing for crack healing. Crack width on the surface and at the reinforcement steel were estimated and recorded in Table 1.

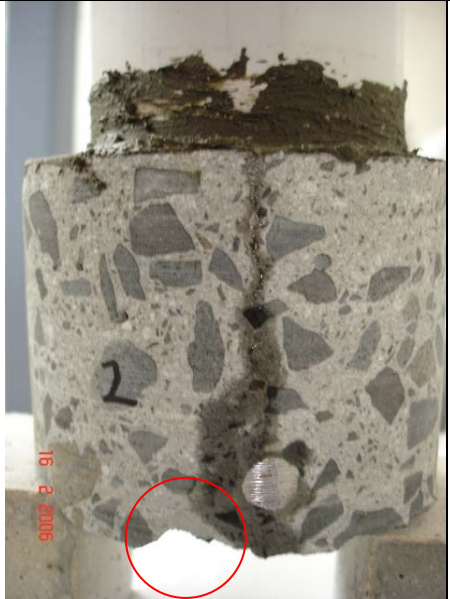
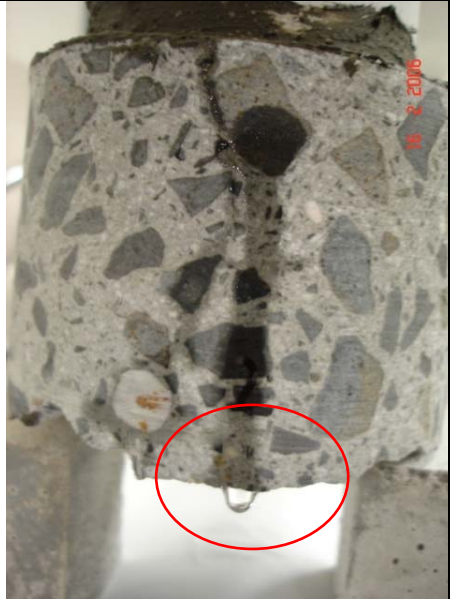
<p>5 min</p>

<p>Note:</p> <ul style="list-style-type: none"> * Leaking from both sides of the crack was observed; * Dampness was observed along the crack from top (surface), through the reinforcement steel bar and to the bottom of the core sample; * Dripping from both sides of the crack was observed as shown in red circle on the left
<p>4 days</p>

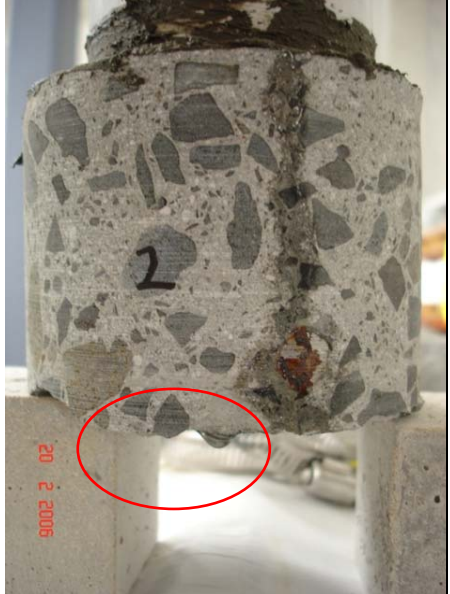
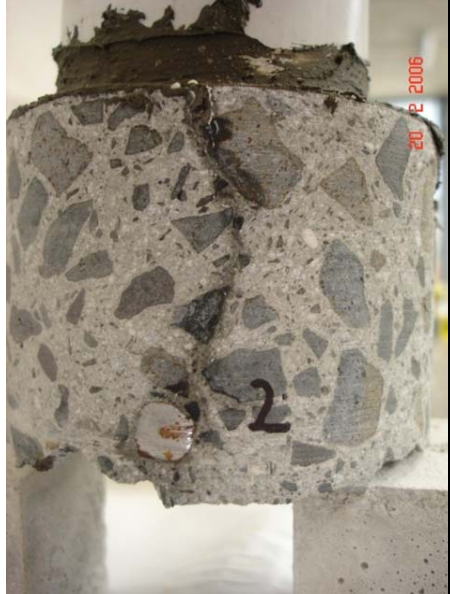
<p>Note:</p> <ul style="list-style-type: none"> * Leaking from both sides has significantly reduced after 4 days; * Dripping from Side A continued after 4 days; * Dripping from Side B stopped after 4 days. * Dampness was still notable along the crack and bottom of the core sample

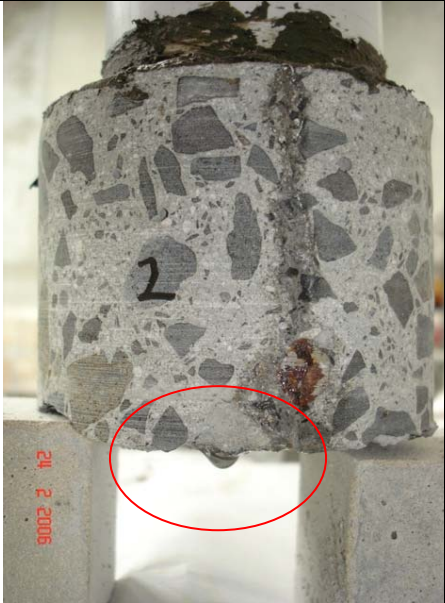
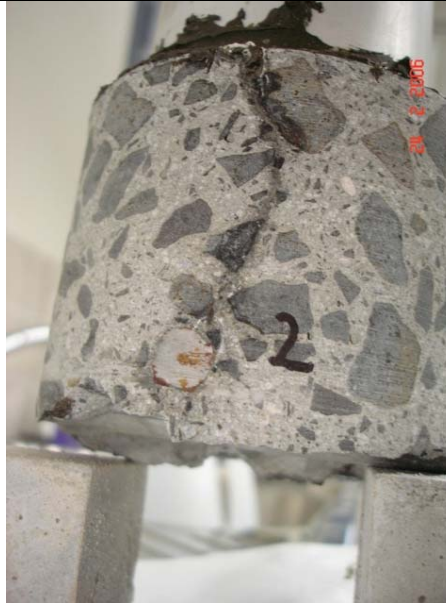
<p>8 days</p>

<p><u>Note:</u></p> <ul style="list-style-type: none"> * Dripping was notable after 8 days (on side A); * Dampness has significantly reduced on the Side B
<p>16 days</p>

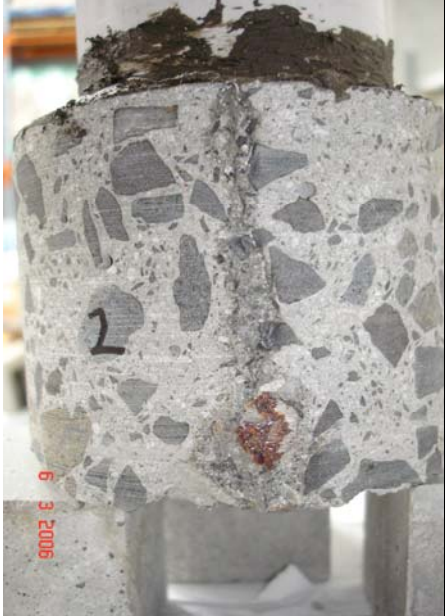
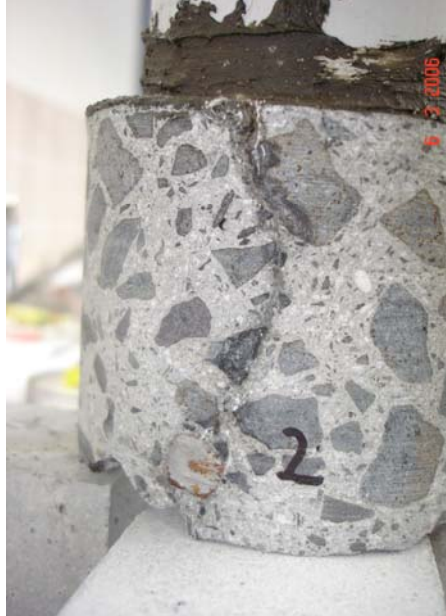
<p><u>Note:</u></p> <ul style="list-style-type: none"> * No dripping was observed on both sides of the crack (Side A & Side B); * dampness was still notable at bottom of core sample (Side A ONLY) * No dampness on Side B.

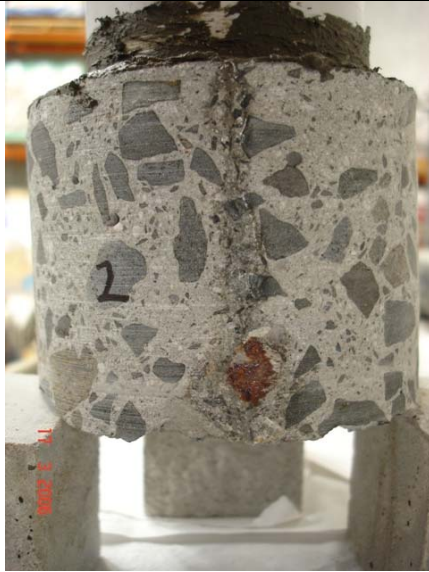
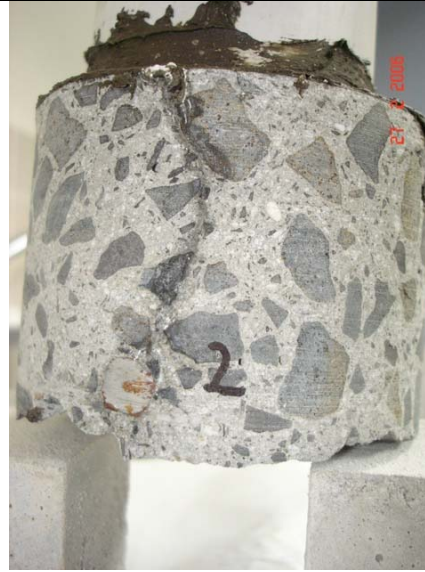
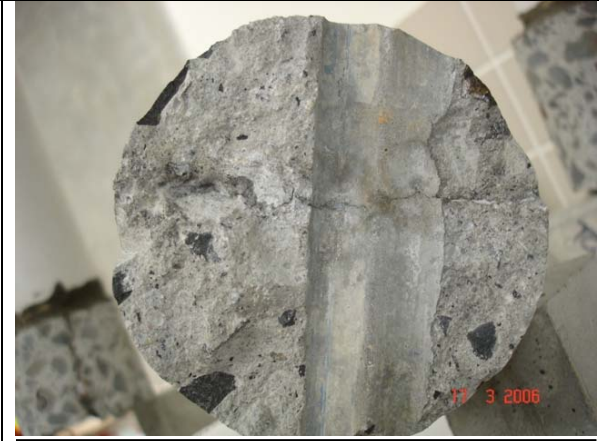
29 days

* No leaking & Dampness could be observed on both sides of the crack and also the bottom of the core sample, as shown above.

* The core sample remains dry

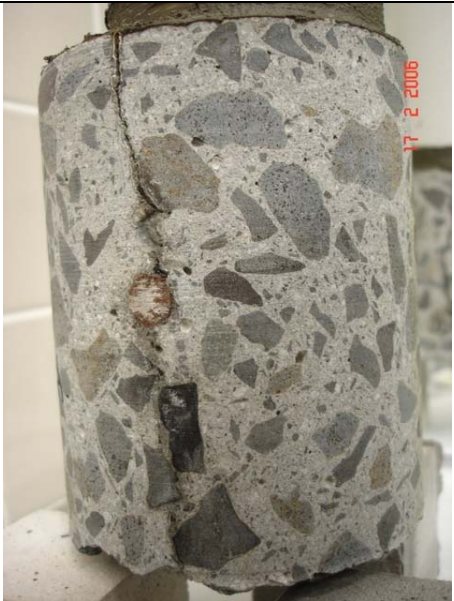
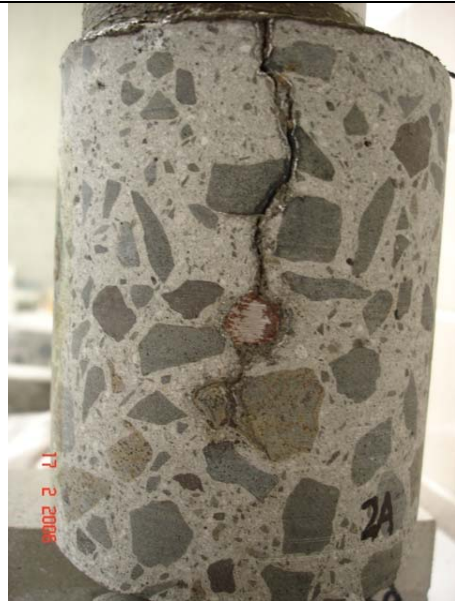
4 days

A cylindrical concrete specimen with aggregate visible. A vertical crack runs down the center. A red circular mark is visible on the left side. A red date stamp '17 2 2006' is on the left edge. The label '2A' is visible on the right side.	<p>Note:</p> <ul style="list-style-type: none"> * At first five minutes, leaking was observed along the crack on both sides and also at reinforcement steel; * Leaking has significantly reduced after 4 days; * Leaking has stopped after 8 days; no signs of dampness were notable at both reinforcement steel and crack after 8 days; * No leaking and dampness were found after 16 days
8 days

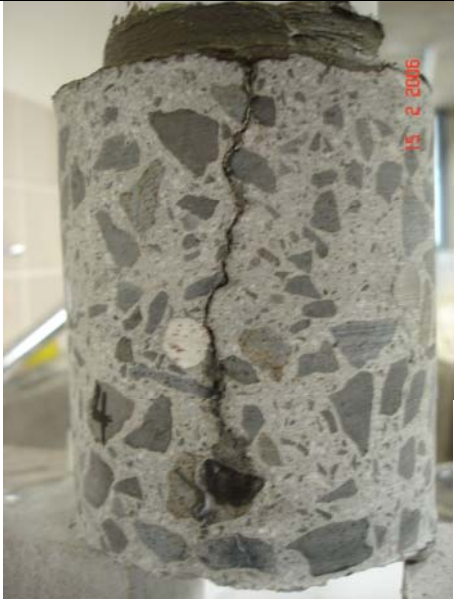
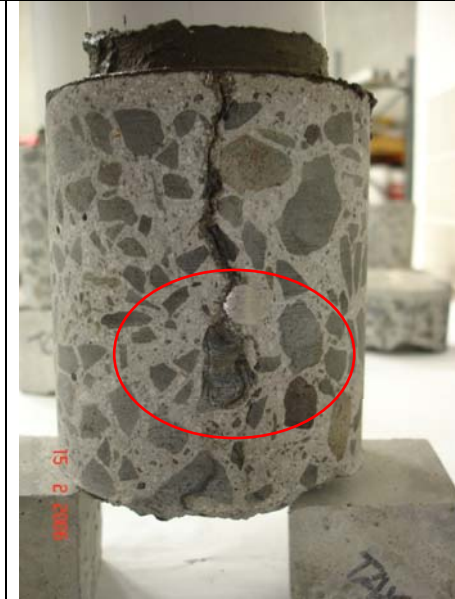
<p>4 days</p>

<p><u>Note:</u></p> <ul style="list-style-type: none"> * Leaking has significantly reduced after 4 days; * dampness along the crack on the Side A was notable; * Dry moisture stains (marked in red circle) on the Side B was noticed at 4th day of testing; however, dampness along the crack on the Side B was still notable
<p>8 days</p>

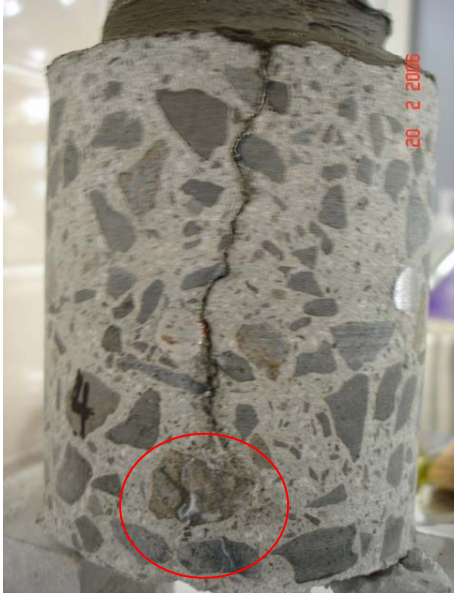
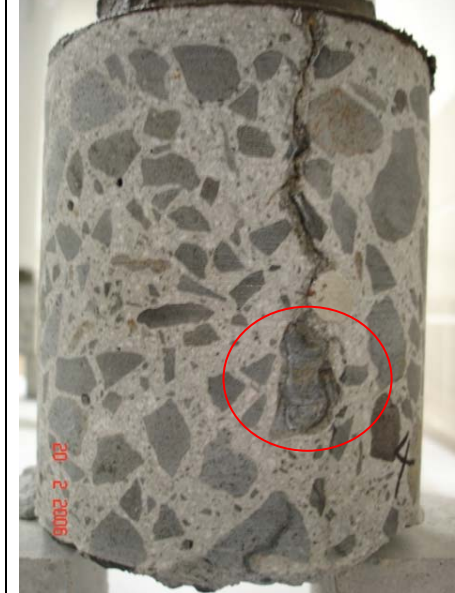
<p><u>Note:</u></p> <ul style="list-style-type: none"> * Leaking has stopped after 8 days; * No dampness has observed along the crack on both sides of the crack after 8 days; * Dry moisture stains have observed on both sides of the crack (marked in red circles)

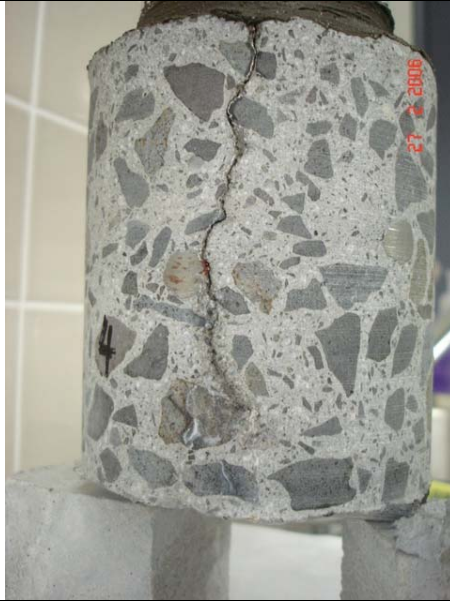
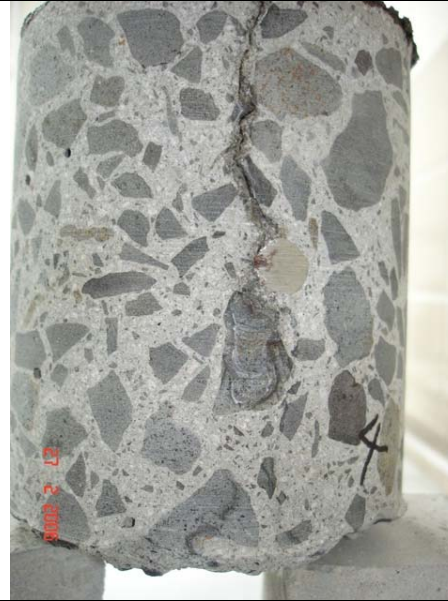
- * Core sample remains dry;
- * No leaking and dampness have observed after 16 days of testing.
- * Dry moisture stains are still notable after 16 days

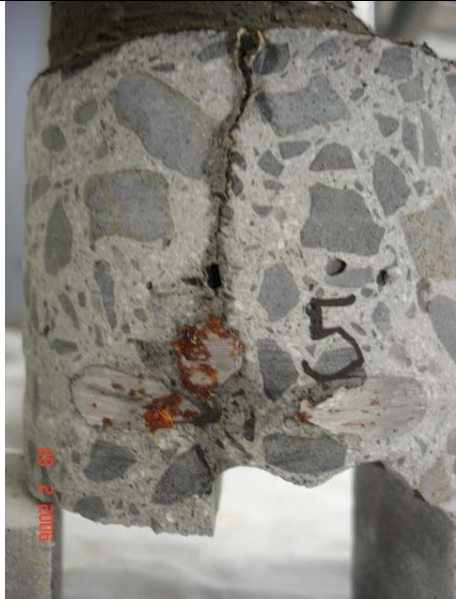
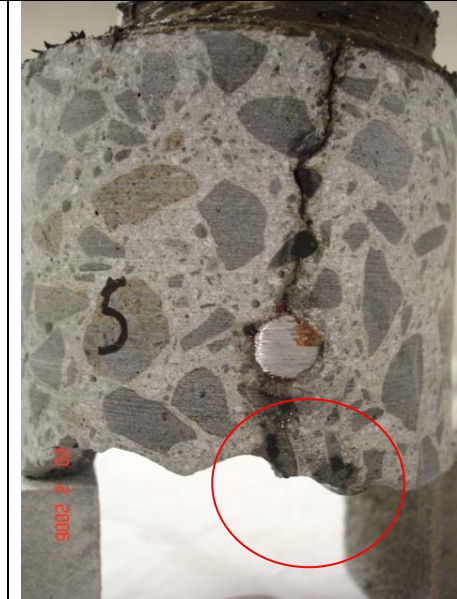
<p>4 days</p>

<p><u>Note:</u></p> <ul style="list-style-type: none"> * Leaking has significantly reduced after 4 days * Dripping from Side A stopped after 4 days; dampness was notable * Dripping from Side B has slowed down after 4 days
<p>8 days</p>

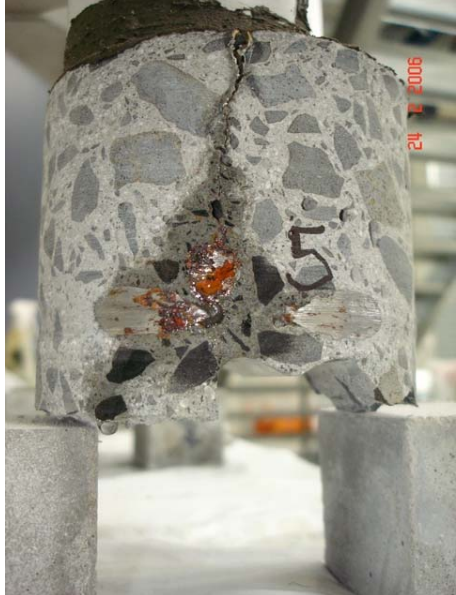
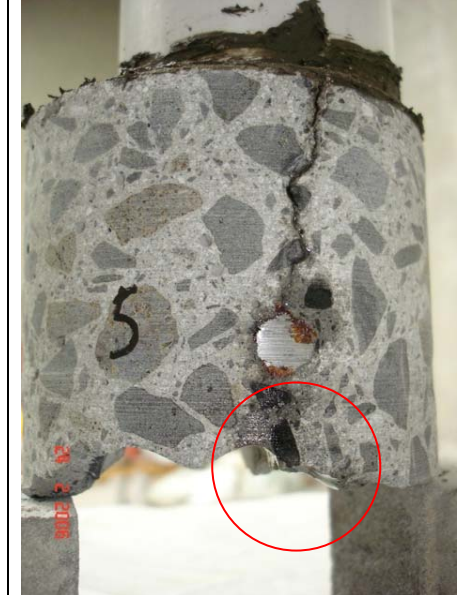
<p><u>Note:</u></p> <ul style="list-style-type: none"> * Leaking has significantly reduced after 4 days; * Dampness was increased on Side A of the crack * Dripping from Side B was still notable

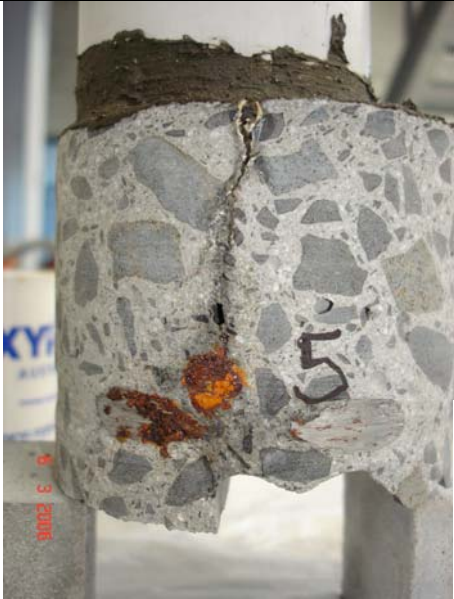
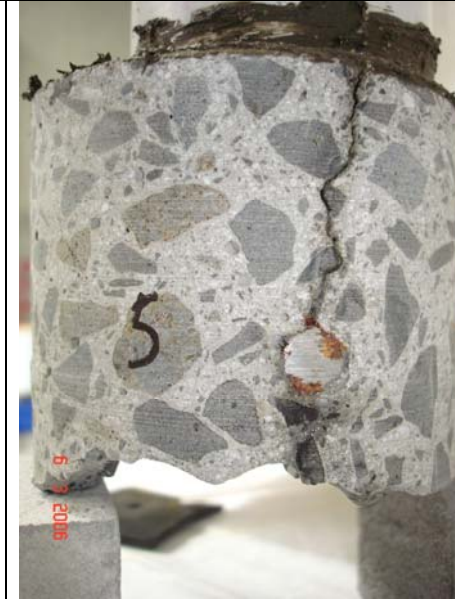
<p>16 days</p>

<p>Note:</p> <ul style="list-style-type: none"> * Large amount of corrosion by-products have been observed on the Side A of the crack * Dampness on Side A has reduced * Leaking from Side B of the core has reduced * Dripping from Side B has significantly reduced
<p>29 days</p>

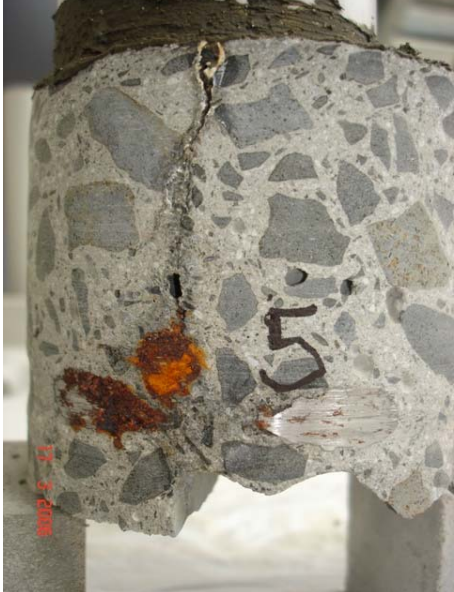
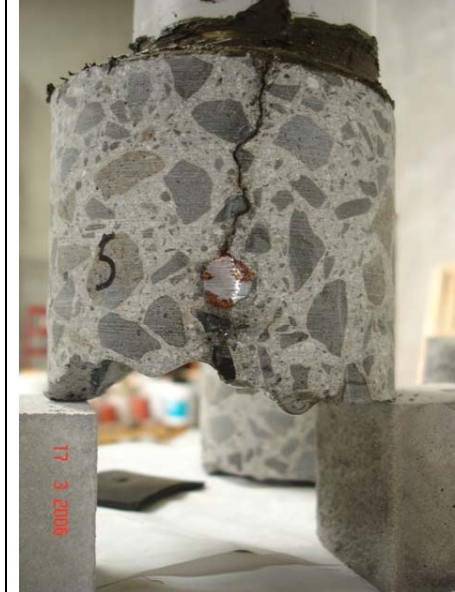
<p>Note:</p> <ul style="list-style-type: none"> * Large amount of corrosion by-products remain on the steel reinforcement after 29 days; * Dripping from Side B is still notable
