Concrete Waterproofing Manufacturing Pty Ltd
T/A XYPEX AUSTRALIA
ABN 96 093 161 963

**Project Manager
Hansen Yuncken Pty Ltd
25 Huntingdale Road
Burwood, Victoria 3125**

Update - Core samples collected from Monash University Car Park, VIC

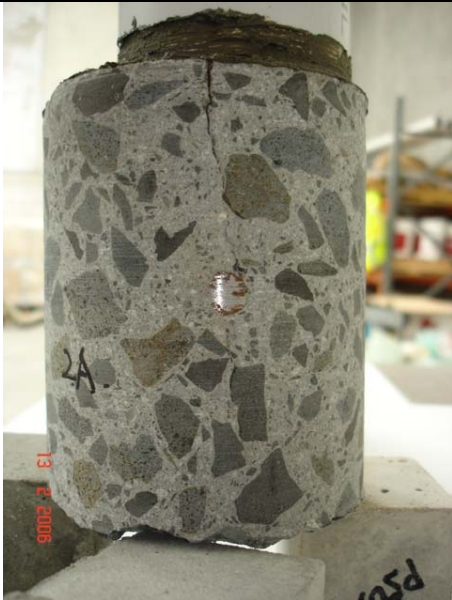
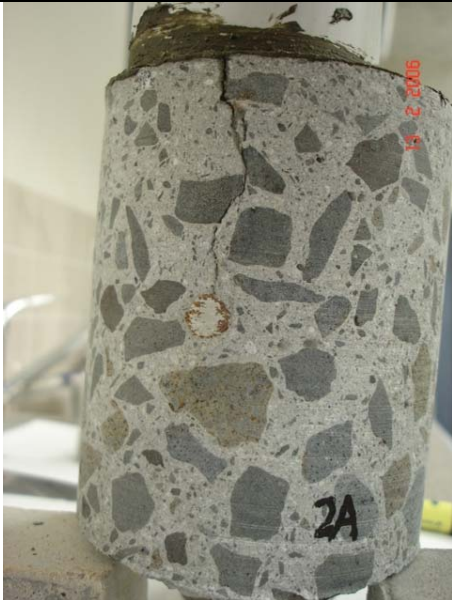
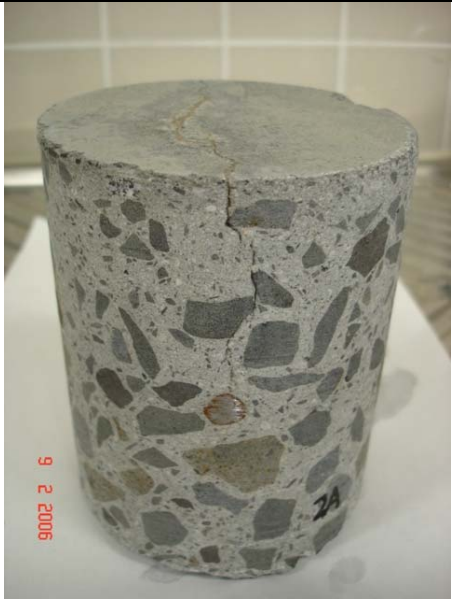
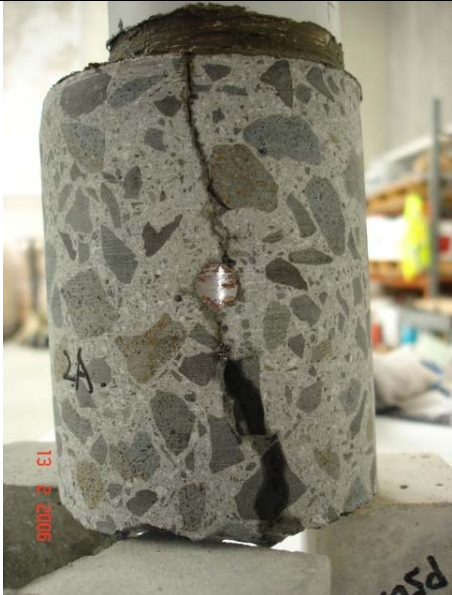
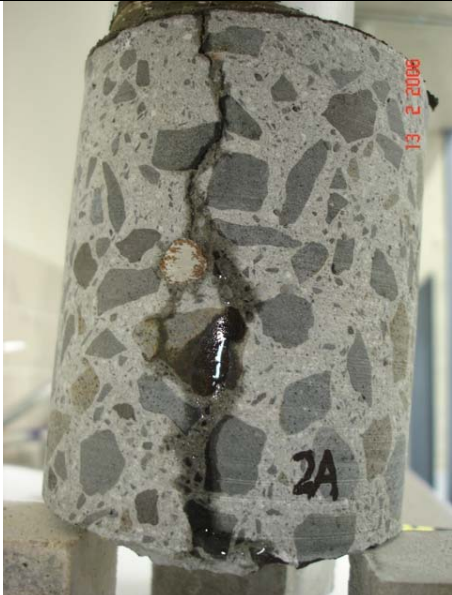
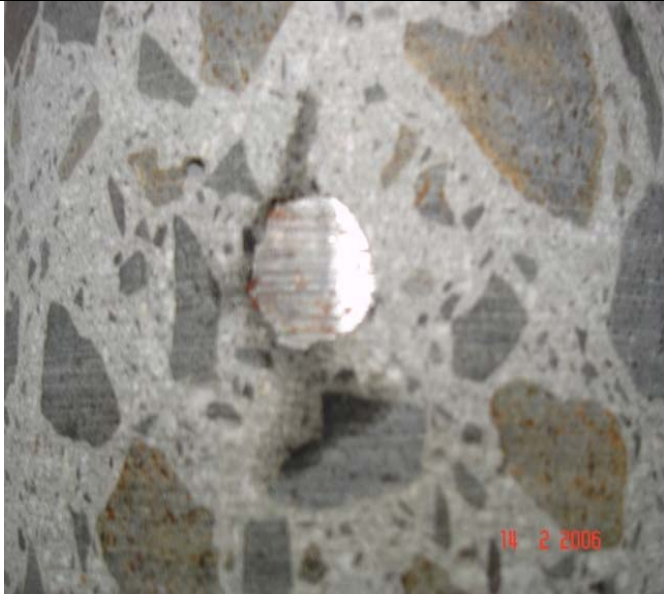
Sample 2A	Side A	Side B	Reinforcement
Elapsed Time (days)			
0 min

A cylindrical concrete specimen with aggregate visible. A vertical crack runs down the center. A red circular mark is visible on the left side. A red date stamp '17 2 2006' is on the left edge. The label '2A' is visible on the right side.	<p>Note:</p> <ul style="list-style-type: none"> * At first five minutes, leaking was observed along the crack on both sides and also at reinforcement steel; * Leaking has significantly reduced after 4 days; * Leaking has stopped after 8 days; no signs of dampness were notable at both reinforcement steel and crack after 8 days; * No leaking and dampness were found after 16 days
8 days

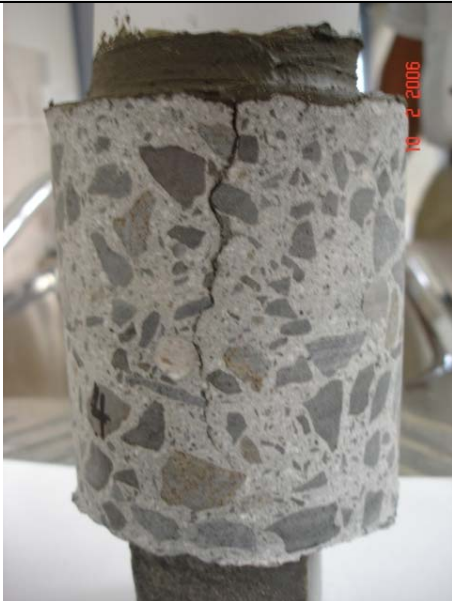
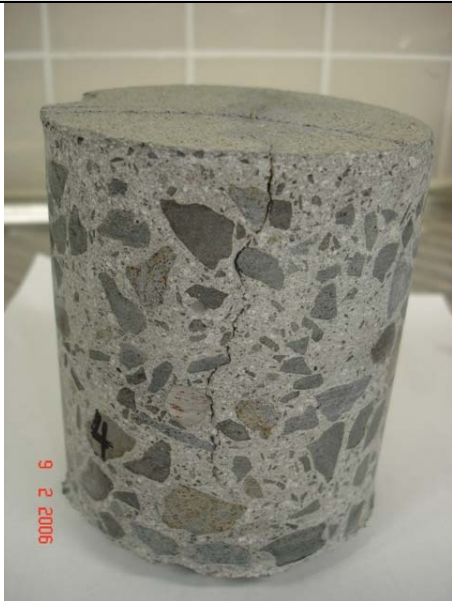
Sample 4	Side A	Side B	Reinforcement
Elapsed Time (days)			
0 min

A cylindrical concrete specimen with aggregate, showing a vertical crack. A red date stamp '9 2 2006' is visible on the left edge.
5 min	  The same concrete specimen as at 0 min, showing the crack and some darkening at the bottom. A red date stamp '9 2 2006' is visible on the right edge.	  The same concrete specimen as at 0 min, showing the crack and some darkening at the bottom. A red date stamp '10 2 2006' is visible on the left edge.	<p>Note:</p> <p>* Leaking on both side of the crack was observed;</p>

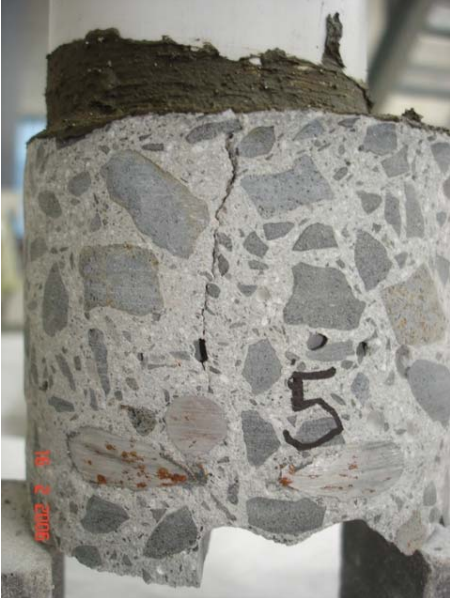
Sample 5	Side A	Side B	Reinforcement
Elapsed Time (days)			
0 min

A vertical concrete sample with aggregate visible. A vertical crack runs down the center. A black number '5' is handwritten on the right side. A red date stamp '16 2 2006' is at the bottom left.	  A vertical concrete sample with aggregate visible. A vertical crack runs down the center. A black number '5' is handwritten on the left side. A red date stamp '16 2 2006' is at the bottom left.	  A circular cross-section of the concrete sample. A horizontal crack runs across the middle. A black number '5' is handwritten on the right side. A red date stamp '16 2 2006' is at the bottom right.
5 min	  A vertical concrete sample with aggregate visible. A vertical crack runs down the center. A black number '5' is handwritten on the right side. A red date stamp '16 2 2006' is at the bottom left. A red circle highlights a dark, wet area at the bottom of the crack.	  A vertical concrete sample with aggregate visible. A vertical crack runs down the center. A black number '5' is handwritten on the left side. A red date stamp '16 2 2006' is at the bottom left. A red circle highlights a dark, wet area at the bottom of the crack.	<p>Note:</p> <p>* Leaking was observed along both sides of the crack; dripping was found on both sides of the crack</p>
